IN THE CIRCUIT COURT FOR DAVIDSON COUNTY, TENNESSEE

COMPLAINT

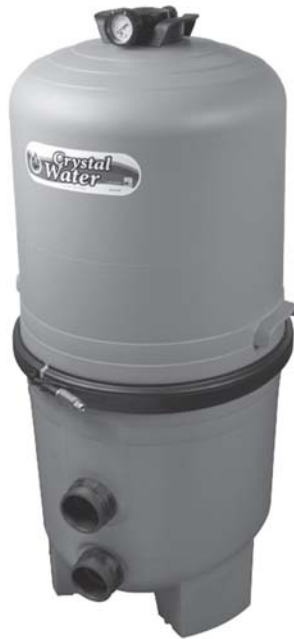
11. This is a photo of a Crystal Water Pool Filter.

12. A metal band holds the top lid to the bottom filter body.

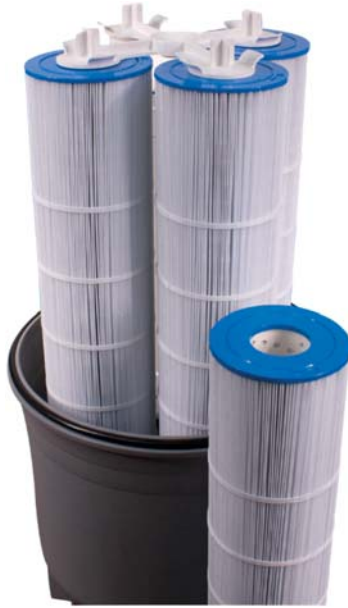
16. This is a photo of cartridges installed in a Crystal Water Pool Filter with the lid removed.

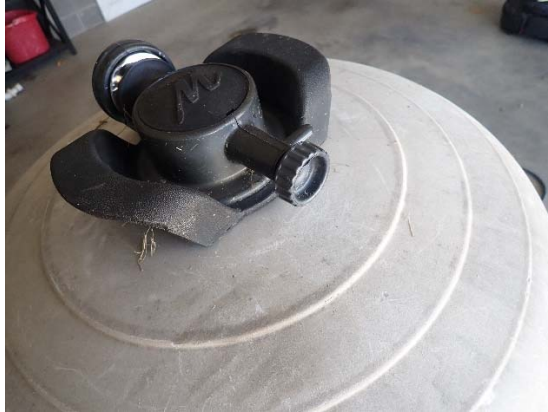
28. This is a photo of a valve on a Crystal Water Pool Filter.

29. The valve is supposed to aid in bleeding unwanted air when restarting the filter.
30. The manual air valve on Crystal Water Pool Filters is too small to reliably relieve the pressure building during startup.

31. The valve is designed to be turned by hand.
32. Crystal Water Pool Filters do not alert users as to whether the valve is partially open or fully open.
